Case Study:
Philadelphia Suburbs

Home Construction Type:
Existing Residential
Construction

Reducing Energy and Improving Comfort

Retrofitting An Under-insulated, Leaky Home with CertainTeed's CertaSpray® Spray Polyurethane Foam Insulation

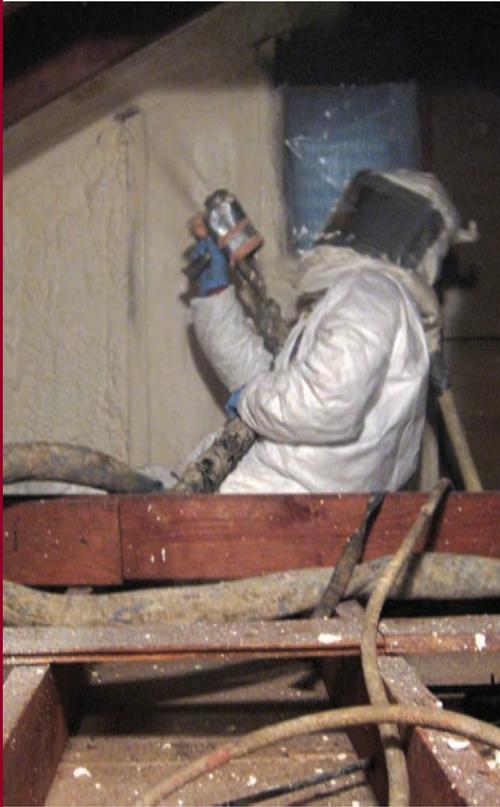
Creating an unvented attic space with closed cell SPF.

The decision was made to convert the existing vented attic into an unvented attic for two reasons – avoiding a costly wiring upgrade and the potential to finish out a 200 sqft. attic space into an extra room, adding \$30,000 to \$40,000 to the home’s value.

This home had a walk-up, ventilated attic with access from the office located above the garage. There were no ducts or recessed lights in the attic. During the initial blower door test, air rushed into the home through this door. Two potential insulation schemes were discussed – a hybrid foam/fiberglass solution on the attic floor or an all-SPF solution on the underside of the roof deck.

However, the decision was made to convert the existing vented attic into an unvented attic for two reasons – avoiding a costly wiring upgrade and the potential to finish out a 200 sqft. attic space into an extra room, adding \$30,000 to \$40,000 to the home’s value. A sprayable intumescent paint tested as a 15-minute thermal barrier was applied to the SPF sprayed in the attic. This was a conservative measure, as code only requires passing the ignition barrier test for non-storage attic space.

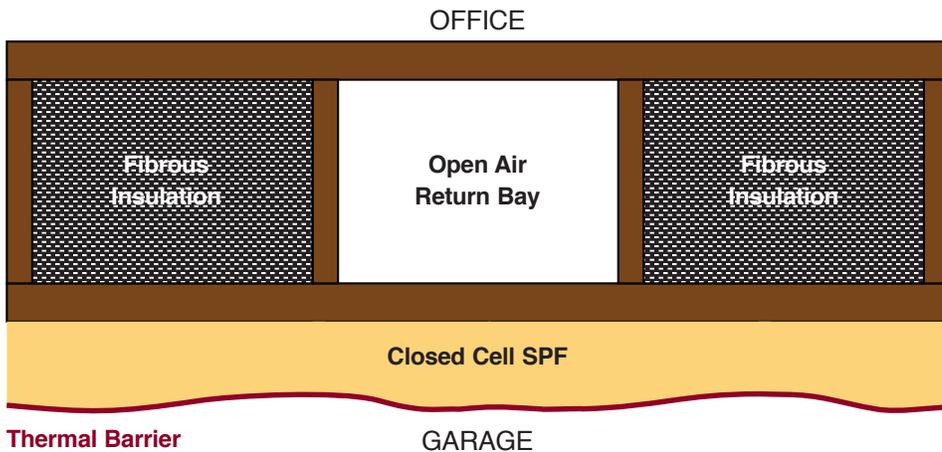
As required by code, a 15-minute sprayable thermal barrier coating was applied to the SPF.

To insulate and air seal the area between the hardwood floor and the garage ceiling, fibrous insulation was installed through holes drilled in each bay (taking caution not to fill the bay being used as the cold air return). This put insulation in contact with all six sides of the bay including the office floor. To air seal the garage

ceiling, three inches of CertaSpray Closed Cell SPF was added on the underside of the ceiling, covering the installation holes and any gaps at the top plate connection.

With this hybrid approach, closed cell SPF, a vapor retarder, was placed on the cold side of this assembly. Therefore, three inches of the SPF were used to ensure the interface between the garage ceiling and fibrous insulation would stay warm enough to eliminate condensation concerns. As required by code, a 15-minute sprayable thermal barrier coating was applied to the SPF.

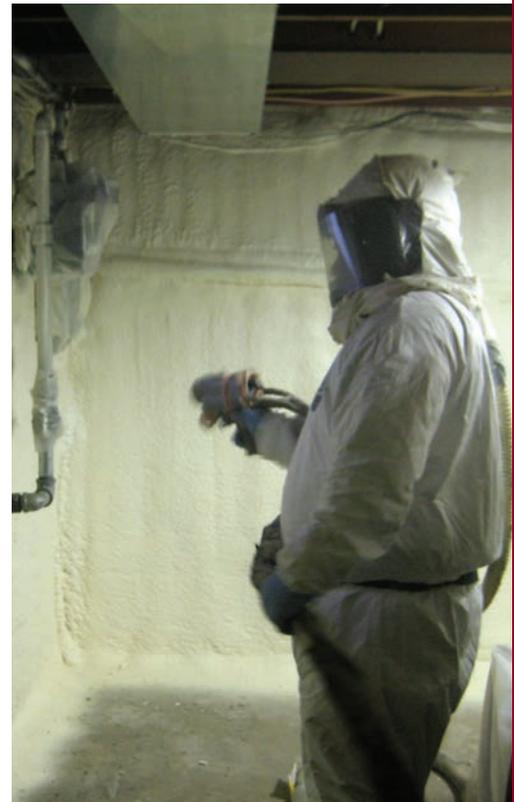
Insulating the basement walls to put ducts inside the conditioned space.

The existing basement and subfloor contained no insulation at all. The decision was between insulating the subfloor or the basement walls. Because the ducts were in the basement, the decision was made to insulate basement walls with one-and-a-half inches of CertaSpray Closed Cell SPF directly onto the concrete masonry units, thereby putting the ducts into conditioned space. This approach was expected to have a more significant impact on the home's energy efficiency and comfort. Like the garage and basement applications, the SPF was covered with a 15-minute sprayable thermal barrier. Electrical, gas and plumbing items were protected from SPF using polyethylene sheeting.
