Case Study:
Houston, Texas

Home Construction Type:
Existing Residential
Construction

Houston, We Have A Solution

Comfort and Energy Savings With Open Cell Spray Polyurethane Foam

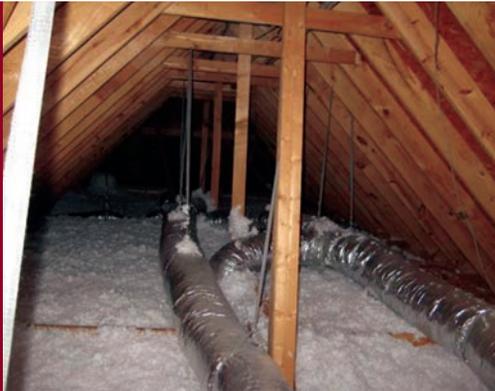
Attic complete after blown-in fiberglass install

The decision was made to spray the attic floor with five-and-a-half inches of open cell SPF. Three-and-a-half inches of fiberglass was blown-in on top of the spray foam. Utilization of the fiberglass provided not only R-13 of insulation, but also the ignition barrier required by code. For vertical sections, an intumescent coating was sprayed onto the foam as the ignition barrier.

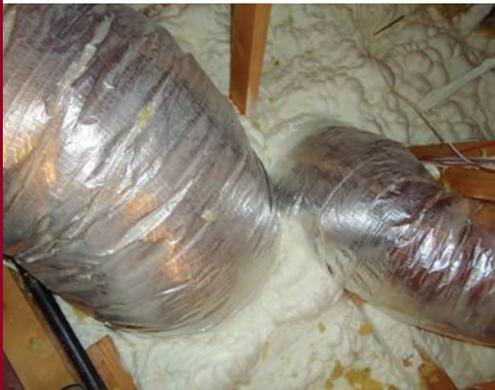
Many insulation problems in an attic start with a misunderstanding of how insulation works. If air is able to move through or around the insulation, the insulation is not performing. This home had open duct chases — hot air filled the duct chase (or open wall cavity), transferring heat to the conditioned space.

Spray foam seals open duct chases

This installation fixed all of the attic issues. For the open duct chases and open walls, polyiso board was used to provide a surface to apply the SPF. The result was an airtight chase and a significant reduction in heat transfer area. In addition, it also resulted in a decrease in duct leakage to the outside.

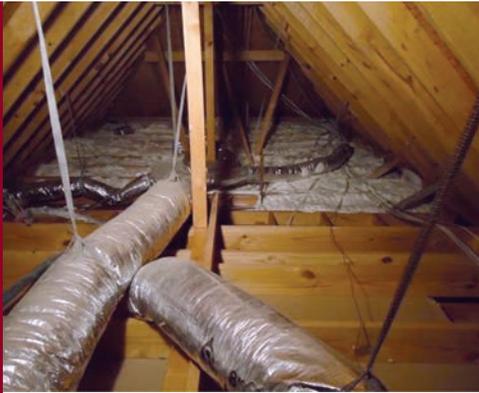
Open cell foam being installed

The existing insulation was removed. Open cell SPF was then applied to the depth of the 2X6s, followed by an application of intumescent coating on vertical surfaces. During application, the HVAC system was shut down, the combustion appliances were switched off and a ventilation fan was used to pull air from the attic and out through a soffit. The occupants spent the night away from the house, entering no sooner than 24 hours after completion of the spraying. The blown-in fiberglass was installed the following day.

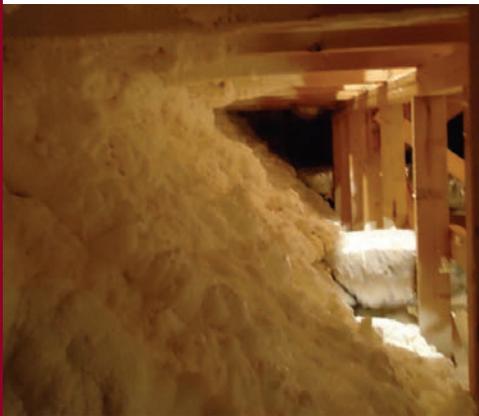
Spray foam fixes open flooring system

For the open flooring system, polyiso boards were used to close off the space between the dining room ceiling and the playroom floor. Spray foam was then applied directly to the gypsum board ceiling, the floor of the playroom, and along the polyiso board bridge between the two.
